Case Report

Biliodigestive Anastomotic Stenosis (Percutaneous)

ARCHIMEDES

Biodegradable Biliary and Pancreatic Stent

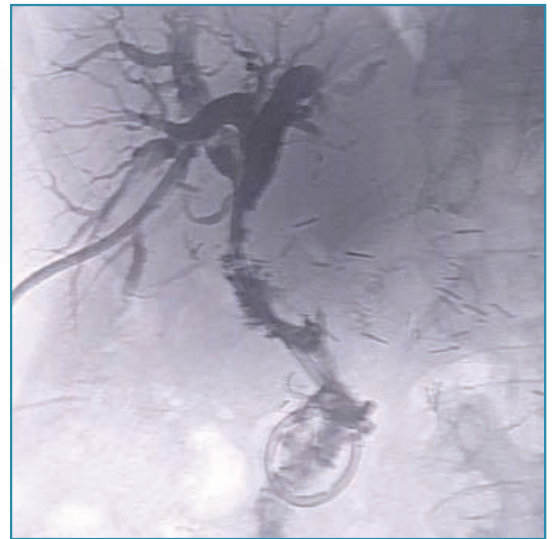
Image 1. Fluoroscopic view of the hepatobiliary track with stenosis, along with a drainage catheter.

65 y/o male patient with prior jejunostomy presented with a benign stenosis resulting from a biliodigestive anastomosis.

Biopsy samples were retrieved during a prior intervention to rule out any malignancy and a 12 mm balloon was also used to dilate the anastomotic stenosis.

The drainage catheter seen in image 1 was removed and a 11 F x 25 cm peel-away introducer set was selected, along with a hydrophilic 0.035" guidewire.

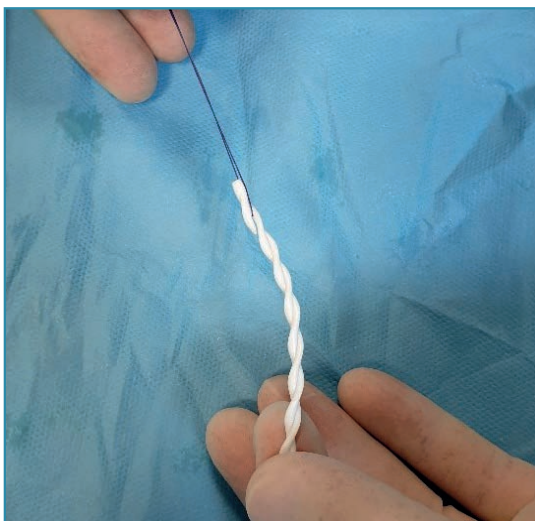
Image 2. Absorbable 3-0 "holding suture" utilized to prevent dislodgment of first stent by second stent.

Due to the possibility of dislodging the first stent during the placement of the second stent, a 3-0 absorbable suture was selected to be placed around the distal flap of the first **ARCHIMEDES** stent (image 2). The "holding suture" would be used in order to retain active control of the first stent, at the time of implantation of the second stent.

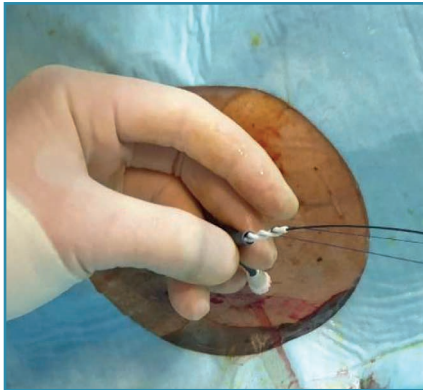
Image 3. Insertion of first the **ARCHIMEDES** stent into the sheath.

The **ARCHIMEDES** stent was introduced into the sheath, with the holding suture in place (image 3) and was implanted successfully, easily negotiating the severe curvature of the duct, with the good support from the introducer sheath (image 4).

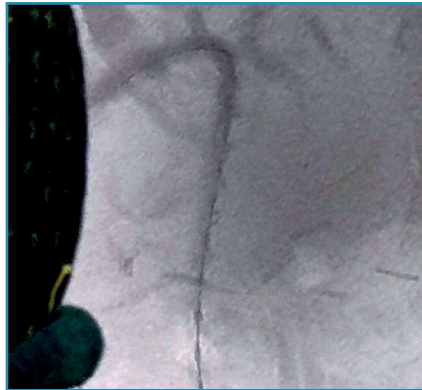
Image 4. Fluoroscopic view of first **ARCHIMEDES** stent in position.

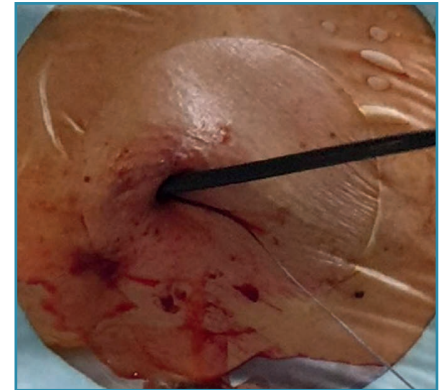
Image 5. Insertion site showing the introducer sheath along with the "holding suture".

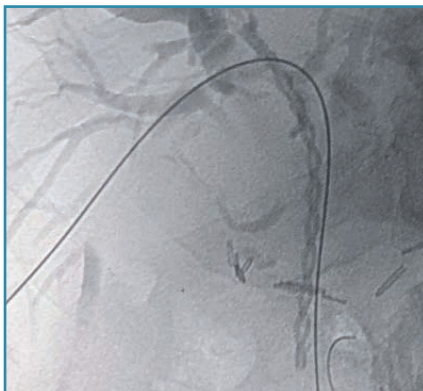
Image 6. Fluoroscopic view of the positioning of the second wire for the second stent.

Introducer sheath was peeled-away and the guidewire was repositioned for the implantation of the second **ARCHIMEDES** stent (image 6 and image 8).

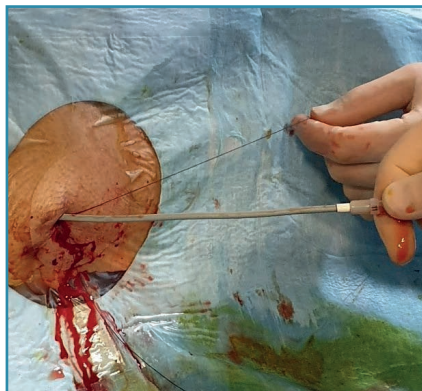
Image 7. Site view; ready for implantation of second **ARCHIMEDES** stent.

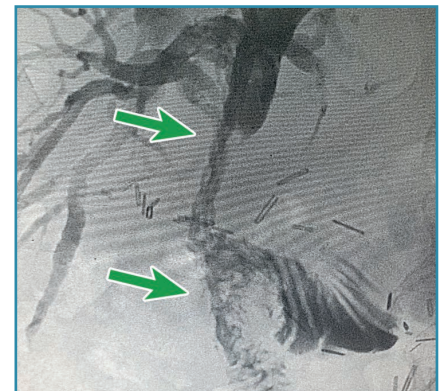
Image 8. Final fluoroscopic view of both **ARCHIMEDES** stents in position.
