Case Report

Cystic Duct Leak & Prophylaxis for PEP

Ordensklinikum Linz
Linz, Austria

Biodegradable Biliary and Pancreatic Stent

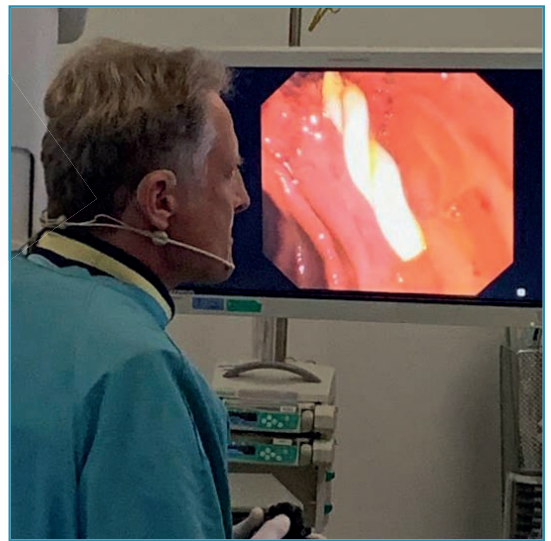
Image 1. Dr. Georg Spaun visualizing the final position of the **ARCHIMEDES** stent placed during a live case presentation in Linz, Austria.

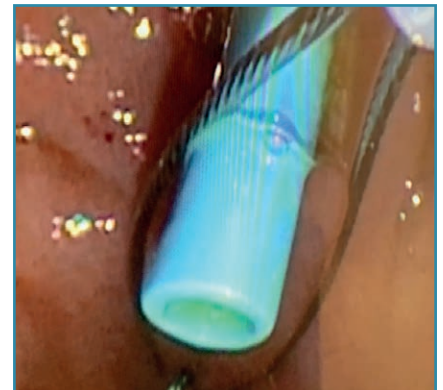
Image 4. Endoscopic view of the retrieval of the second plastic stent (blue) using a snare

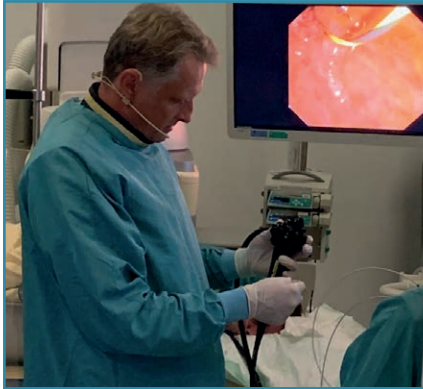
Image 5. Dr. Spaun expertly introducing an 0.035" guidewire into the endoscope just prior to **ARCHIMEDES** stent placement.

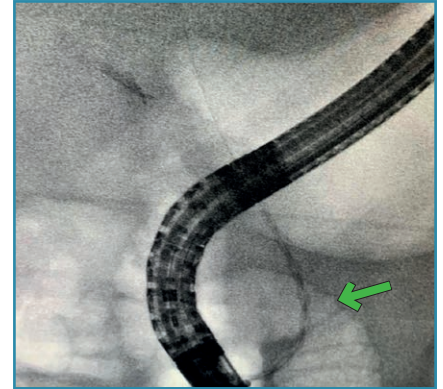
Image 7. Fluoroscopic view of the **ARCHIMEDES** stent being placed over-the-wire into the CBD (green arrow)

The stent can clearly be seen due to the barium sulfate.

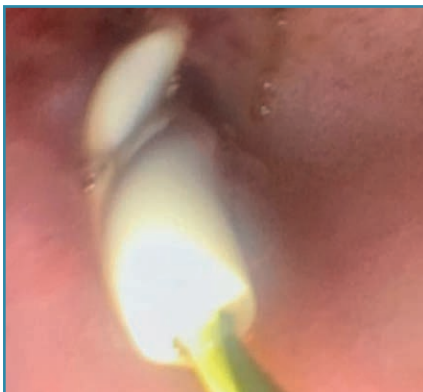
Image 8. Endoscopic view of the distal portion of the **ARCHIMEDES** stent extended out of the papilla into the duodenum.

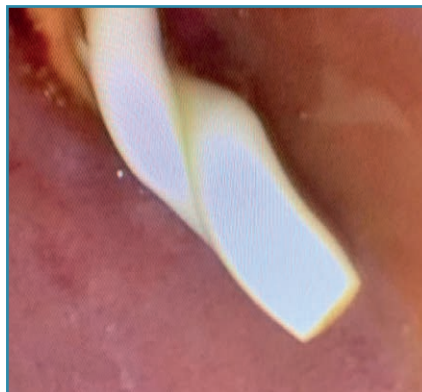
Image 9. Endoscopic view showing the final position of the **ARCHIMEDES** stent with the guidewire removed.
