Case Report

University Hospital Virgen de Arrixaca
Murcia, Spain

ARCHIMEDES

Biodegradable Biliary and Pancreatic Stent

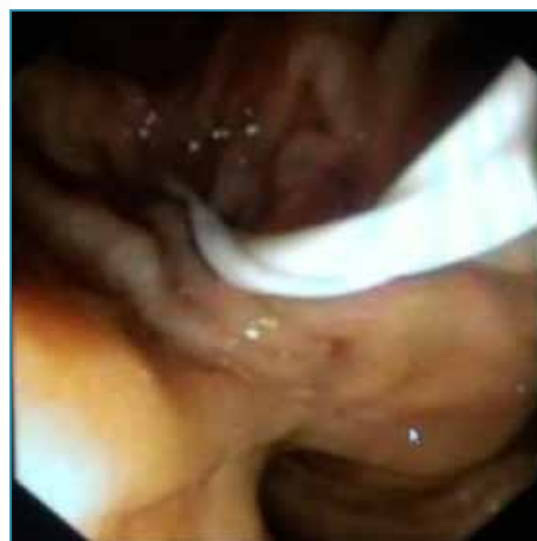
Image 1. Initial of transpapillary positioning of ARCHIMEDES

Under sedation, endoscopist attempted to assess the biliary tree for diagnostic; however, Papilla of Vater was extremely difficult to cannulate due to the presence of some fibrotic tissue. After 20 minutes, the device was exchanged to a thinner 0.021" sphincterotome system; guide-wire was positioned in the biliary duct and contrast injected showing no alterations. No pancreatic duct (PD) suggestive of pancreas divisum, therefore, also no presence of minor papilla.

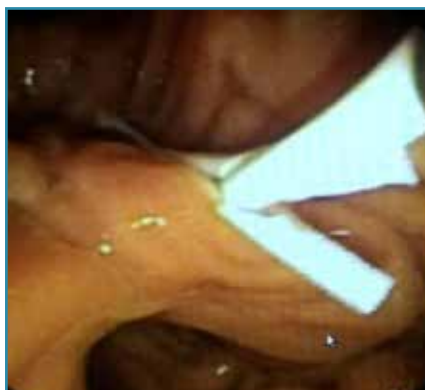
Image 2. Implantation of ARCHIMEDES - view with pusher

Due to the intense manipulation of the papilla, prophylactic pancreatic stent placement was considered to prevent post-ERCP pancreatitis (PEP). Positioning of the guidewire in the pancreatic duct proved very difficult and an 0.025" guidewire was successfully introduced. An **ARCHIMEDES** biodegradable stent (6 F x 40 mm, fast degradation) was smoothly inserted in the PD in a transpapillary position.

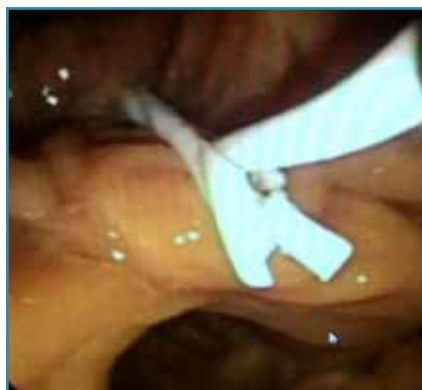
Image 3. Implantation of ARCHIMEDES - view with pusher

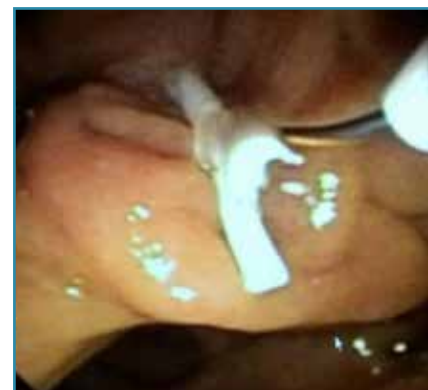
Image 4. Retrieval of pusher, guidewire still in position

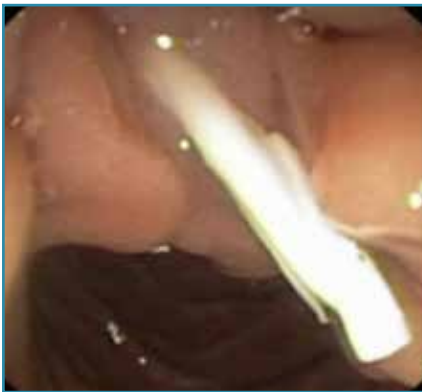
Image 5. Final position of **ARCHIMEDES** biodegradable pancreatic stent

The **ARCHIMEDES** biodegradable stent was prepared per the IFU and implanted in the PD, over a 0.025" guidewire, using a 7 F pushing catheter; procedurally similar to the placement of standard plastic stents.

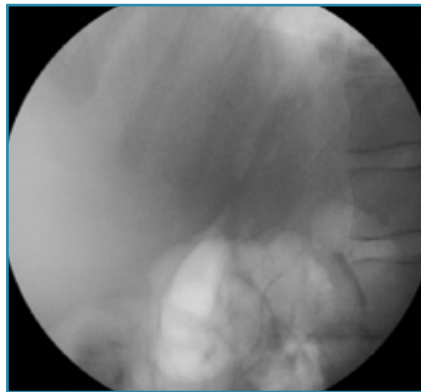
Image 6. Final fluoroscopic view of **ARCHIMEDES** biodegradable stent
