Case Report

St. Thomas Hospital
London, United Kingdom

ARCHIMEDES

Biodegradable Biliary and Pancreatic Stent

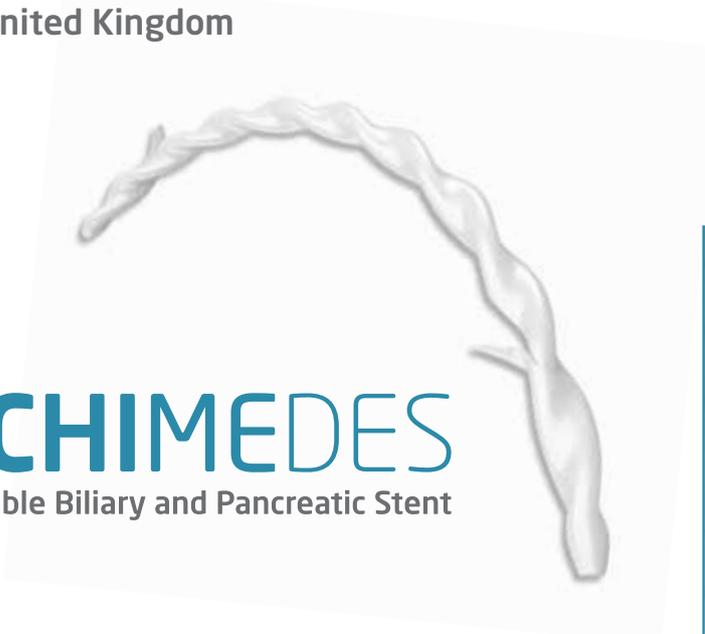
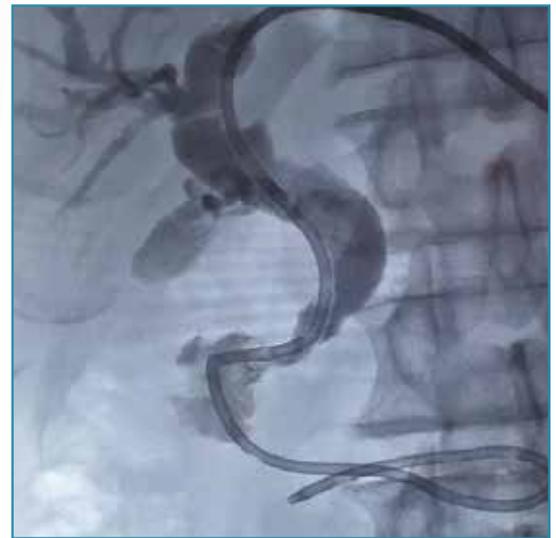
Image 1. Fluoroscopic view showing the drainage catheter and the CBD stenosis.

79 y/o male patient with prior Roux-en Y gastric bypass surgery due to gastric cancer (15 years prior) presented with a stricture at the Common Bile Duct (CBD) of uncertain etiology.

Patient also had a percutaneously inserted biliary drainage catheter which was a significant inconvenience for the patient.

Percutaneous Transhepatic Cholangiography (PTC) was conducted to retrieve tissues samples via brushing at the level of the stricture and to place an **ARCHIMEDES** biodegradable stent to replace the external drainage catheter and treat the stenosis.

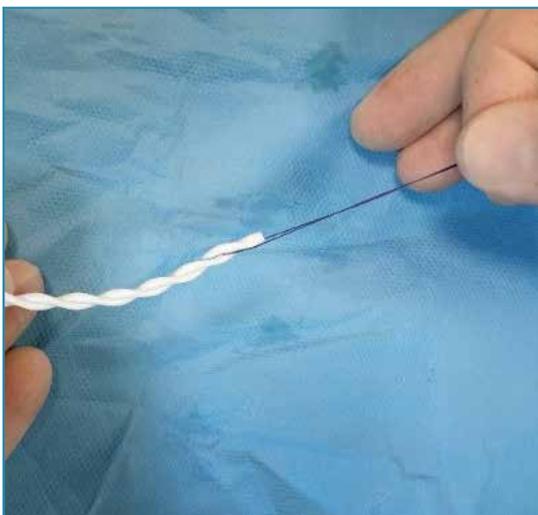
Image 2. Absorbable 2-0 "holding suture" utilized to prevent dislodgment of first stent by second stent.

The 2-0 absorbable suture was selected to be used as a holding suture around the anti-migration flange of the first **ARCHIMEDES** stent (image 2), in order to retain control and position of the stent, while placing the second stent into place.

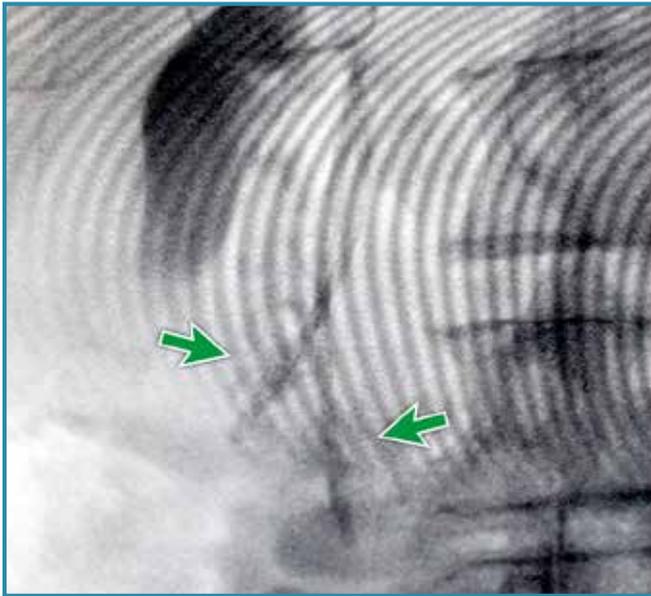
Image 3. Fluoroscopic image showing position of both **ARCHIMEDES** stents.

The **ARCHIMEDES** stent was introduced into the sheath, over the wire, with the holding suture in place and pushed via an 8 F pusher catheter. Following the successful implantation of the first stent, the second stent was implanted utilizing a similar technique, while holding the first stent in position with the holding suture in order to insure accurate placement of both stents. After successful implantation of the second stent, the holding suture was then removed without issue.

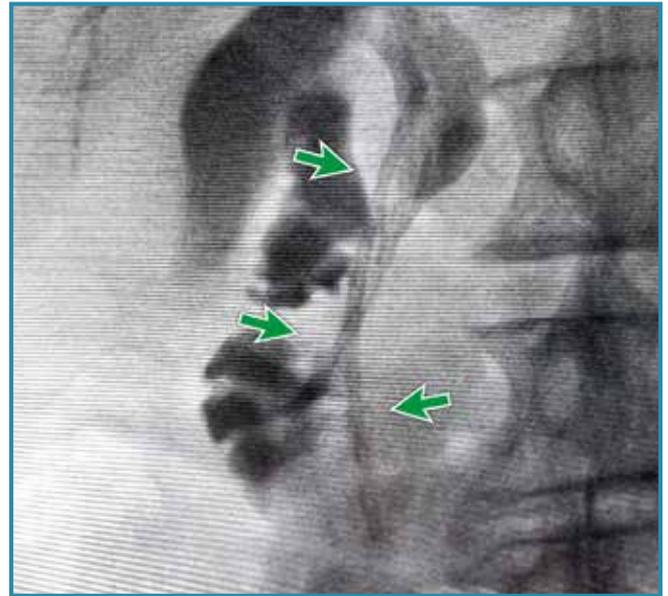
Image 4. Final cholangiogram of **ARCHIMEDES** stents in place.
